D180-18126-1

Final Report

COATING SYSTEM STUDIES FOR THE CORROSION PROTECTION OF HY 130 STEEL

The Boeing Aerospace Company
Naval Systems Division
Seattle, Washington 98124

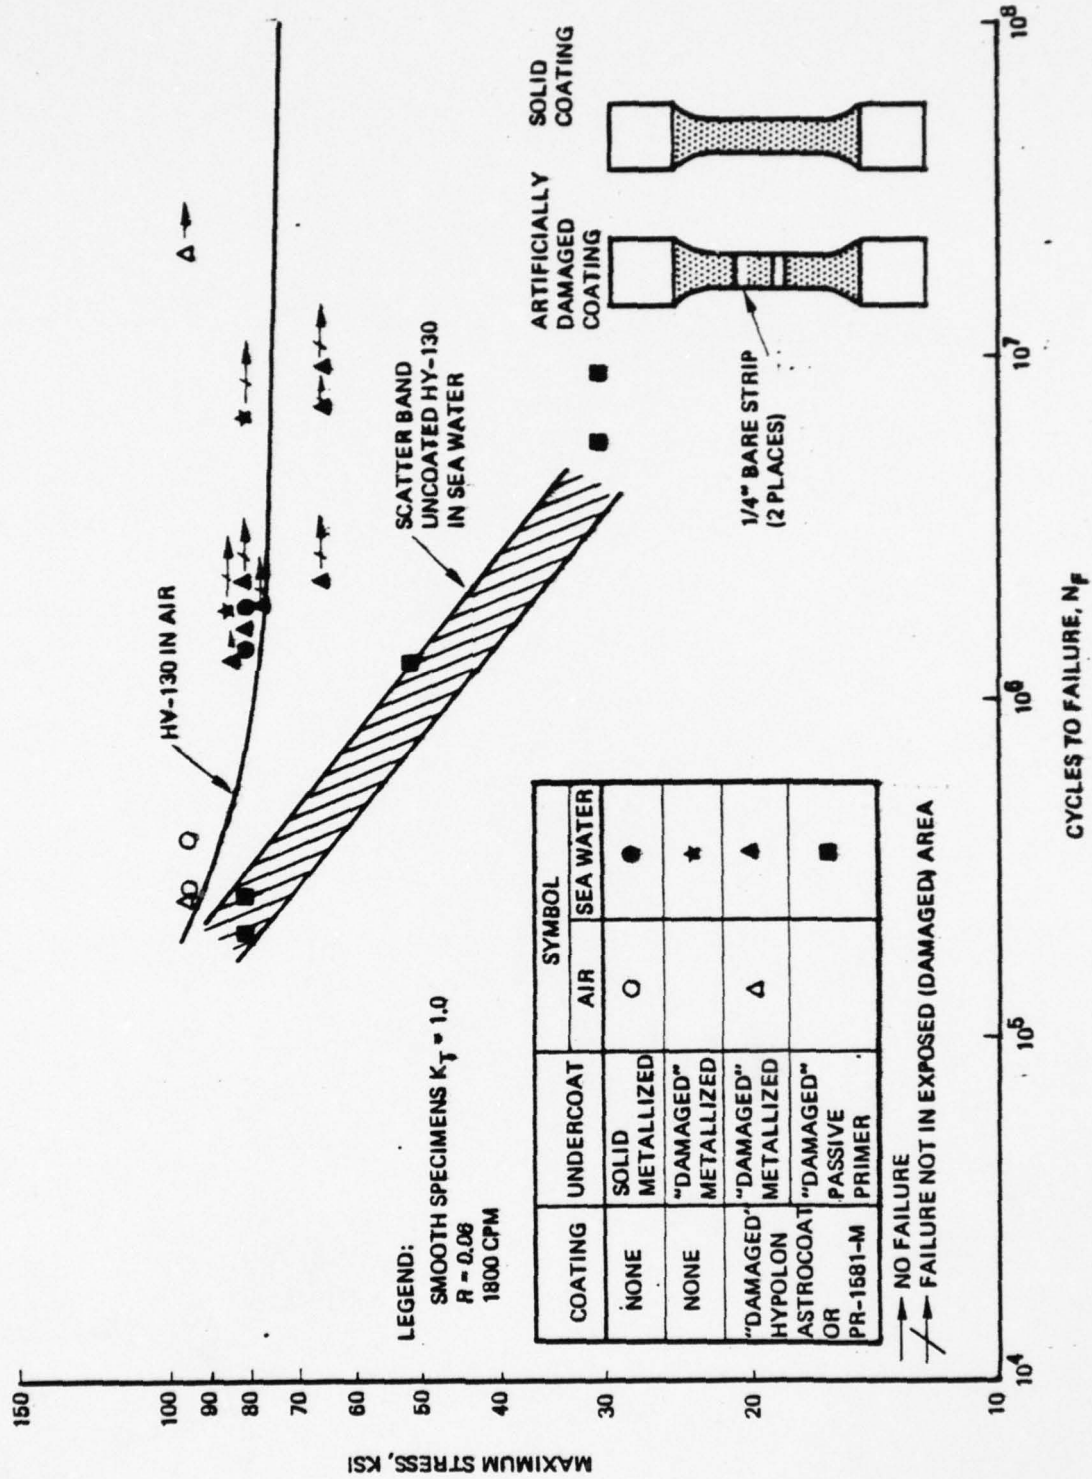
Figure 1: COATED HY-130 STEEL FATIGUE TEST RESULTS (R.E.F. 1)

Results of Boeing Aerospace Company research (1) * have shown that a combination of an active substrate and a passive overcoat appears to be the best approach to provide adequate, reliable protection of low alloy steels in a hydrofoil salt water environment. The Boeing tests of Reference 1 were corrosion fatigue tests conducted on 0.10" thick HY130 specimens which had been coated with a 0.010" thick layer of wire metallized aluminum. These tests were run with and without passive overcoats. Some tests were run with two "damaged" areas (1/4" wide circumferential strips without the aluminum). The results of these tests, Figure 1 showed that the aluminum substrate acted as a sacrificial anode and protected the steel such that the corrosion fatigue life of the protected specimens in sea water was equivalent to unprotected specimens in air. The coating concept was designed to protect the steel from erosion and also to provide short term corrosion protection in case of damage to the passive overcoat.

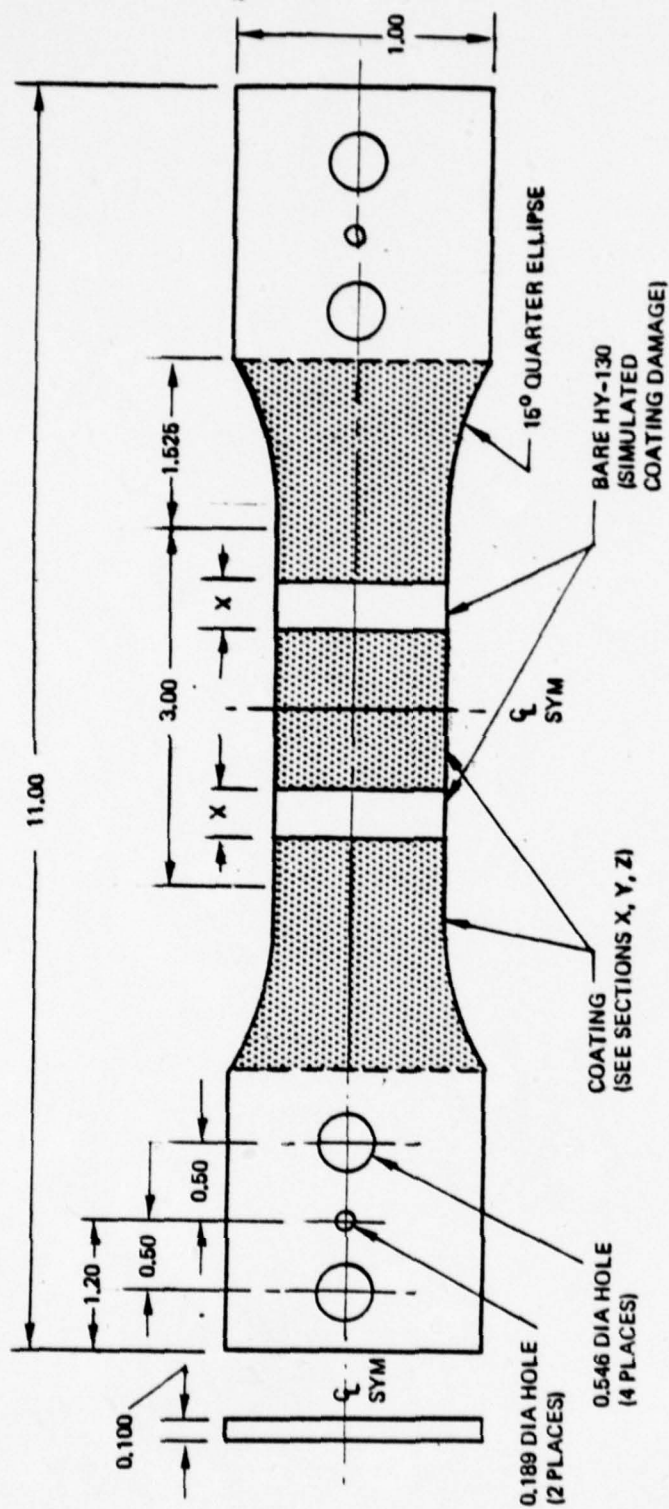
Damaged area produced by masking the base metal during the aluminum metallizing and overcoating. Maskant is stripped after coating to expose base metal to test environment.

Figure 2: "DAMAGED" FATIGUE SPECIMEN

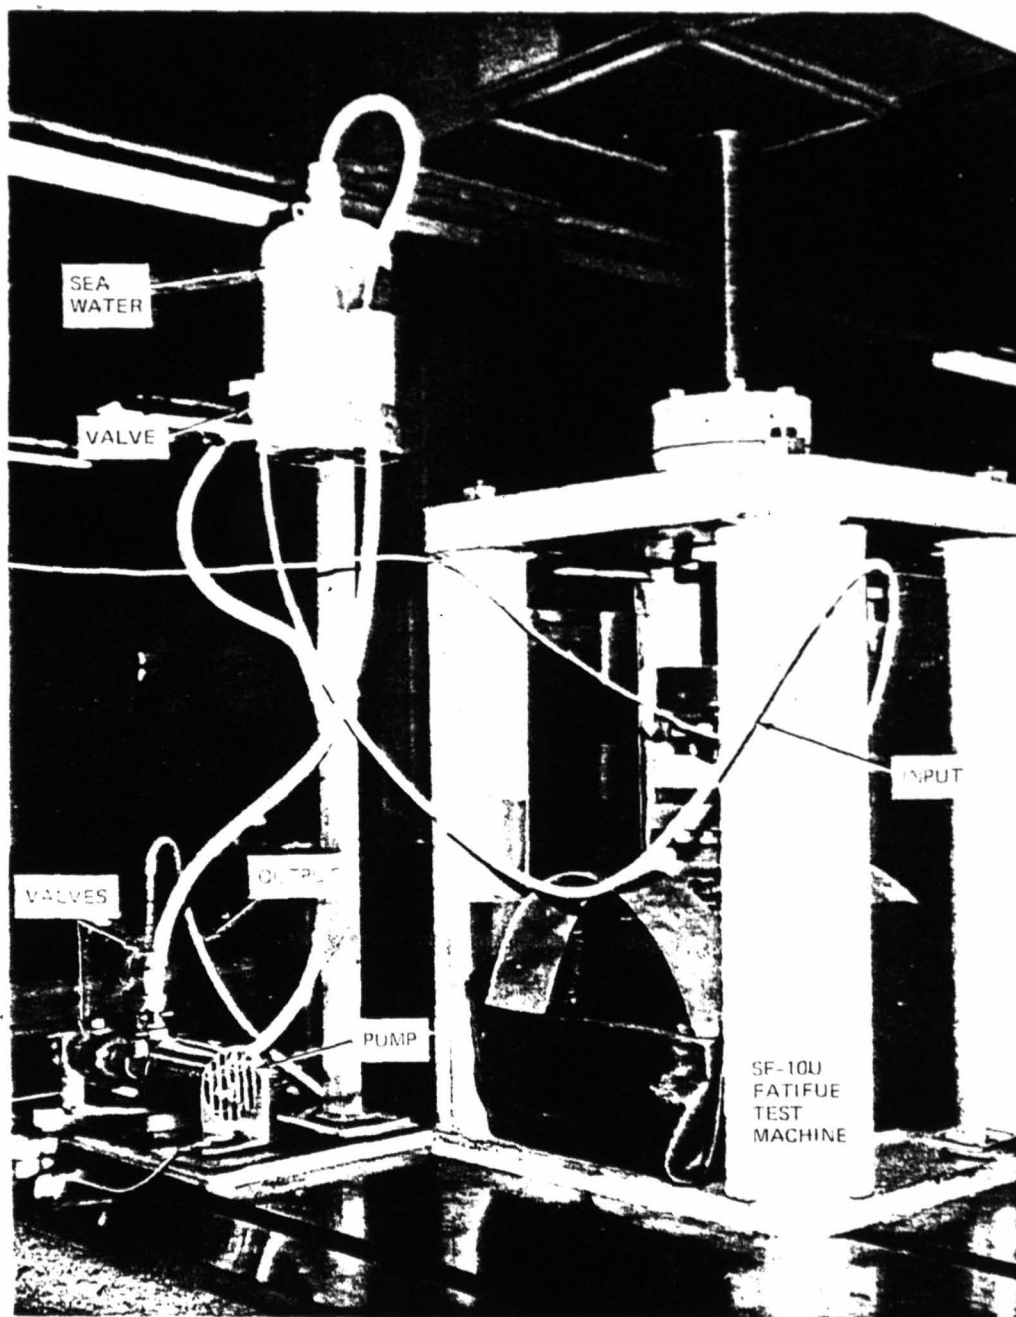
Figure 3: CORROSION FATIGUE TEST SET UP

A circulating pump system was used to supply a continuous flow of aerated ASTM sea water (ASTM designation D1141-52) to the specimens as they were tested. This pump system (Figure 3) was all plastic to protect against galvanic corrosion. The specimens were wetted by ASTM sea water contained in a plastic bag which enclosed the test section. A specimen under test is shown in Figure 4. A schematic of the system is shown in Figure 5.

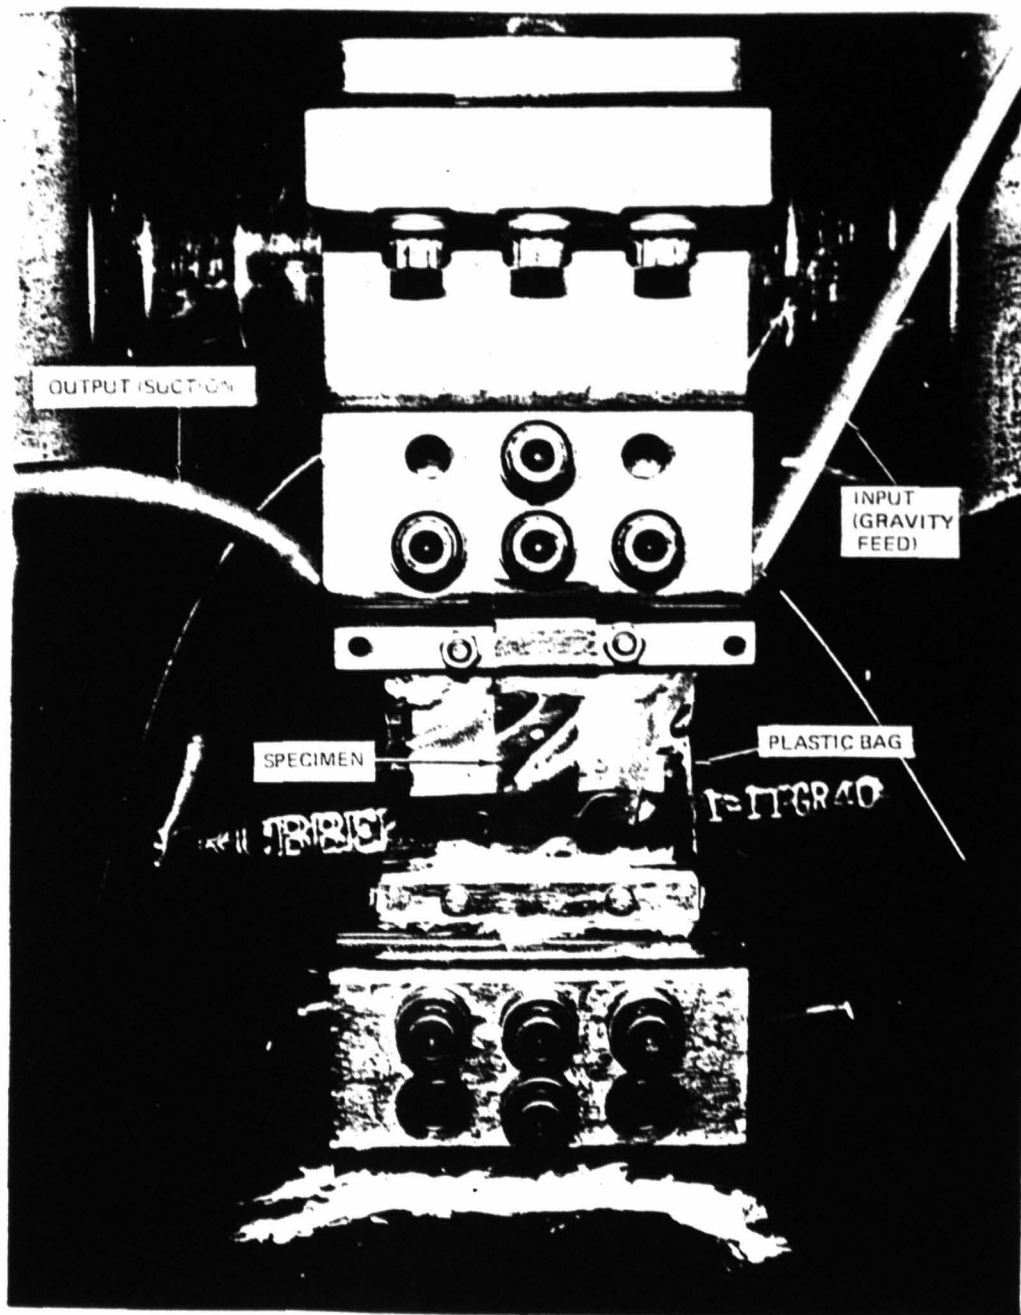
Figure 4:- CLOSE UP OF CORROSION FATIGUE TEST SHOWING PLASTIC BAG ENVIRONMENT CHAMBER

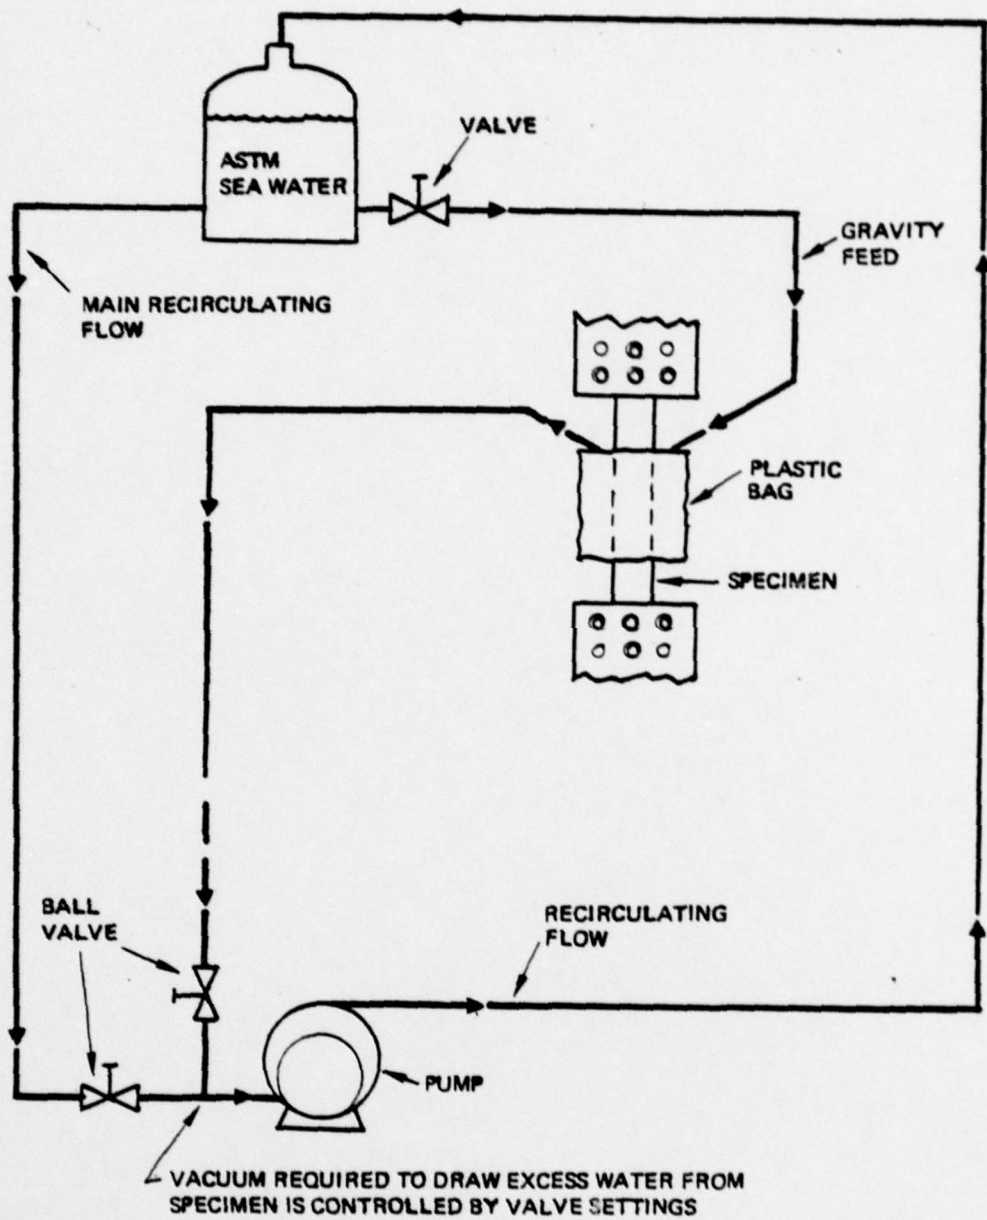
Figure 5: SCHEMATIC OF CORROSION FATIGUE TEST PLUMBING SETUP

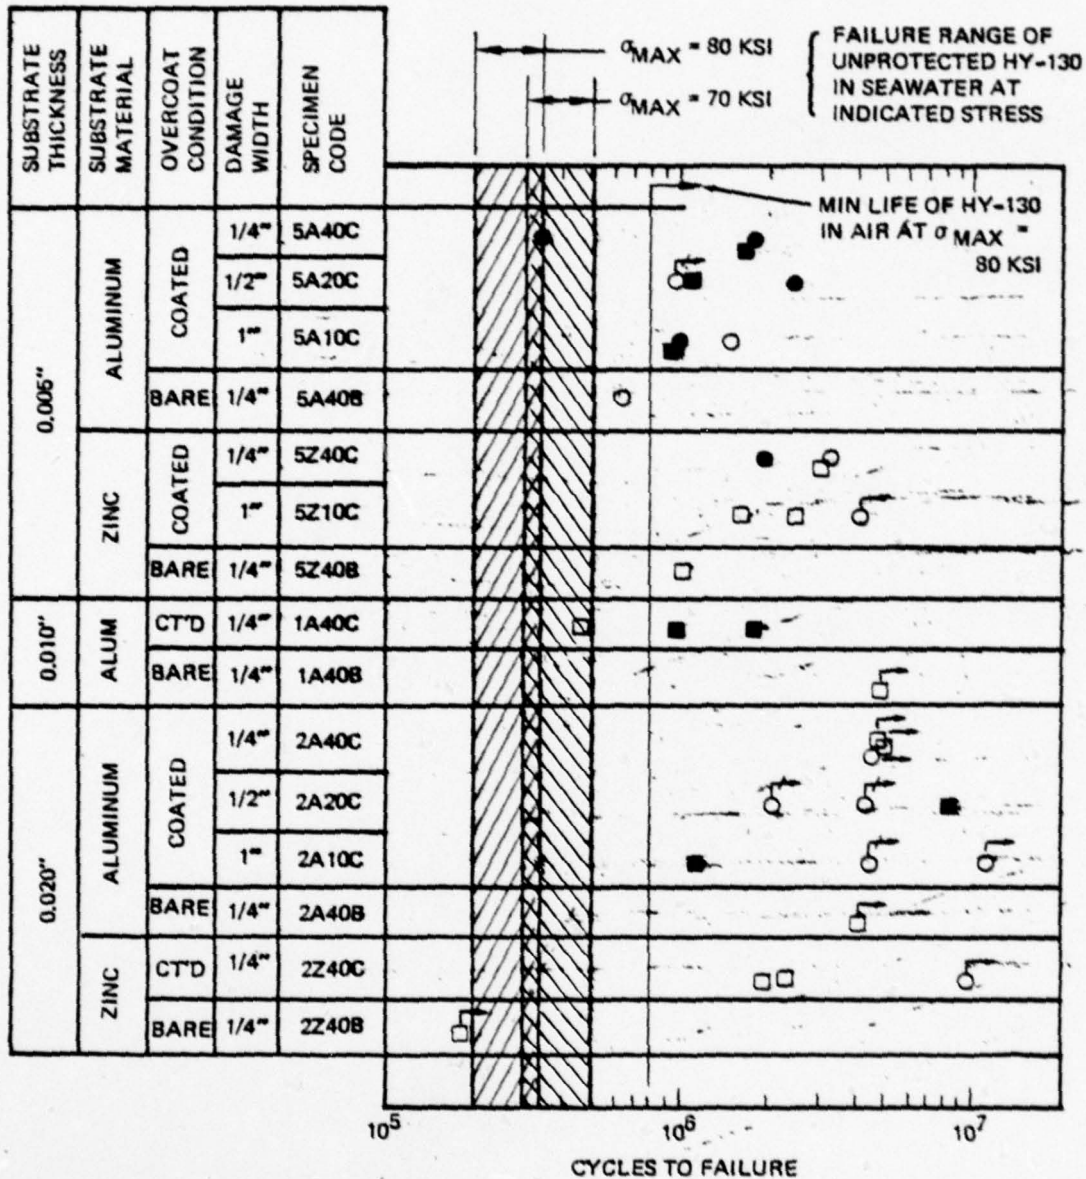
$\sigma_{MAX} = 70$ KSI $\sigma_{MAX} = 80$ KSI FAILURE LOCATION
 ● ■ DAMAGED AREA
 ○ □ COATED AREA
 ○—○ □—□ NO FAILURE
 ○—○—○ □—□—□ GRIP FAILURE
 R = 0.08

Figure 6: CYCLES TO FAILURE FOR COATED HY-130 FATIGUE SPECIMENS — NO PRIOR EXPOSURE IN FLOWING SEAWATER

A complete listing of fatigue test results is provided in Tables IV, V and VI, and the results summarized in Figures 6, 7, and 8 for zero, thirty day, and sixty day prior sea water exposures, respectively. In these figures, a set of four symbols are used to describe the type of failure (i.e., in the coating damaged zone, under the coating away from the damaged zone, grip failure, and no failure). Included in these figures are the fatigue lives for unprotected HY130 in sea water at $\sigma_{\max} = 70$ ksi and $\sigma_{\max} = 80$ ksi plus the minimum fatigue life in air at 80 ksi (reference 1). Figures 6, 7, and 8 show that with two exceptions, all specimens experienced test lives longer than unprotected HY130 in sea water. The two exceptions were bare zinc metallized specimens 2Z40B-1 and 5Z43B-2. Examination of specimen 5Z43B-2 showed that a slight surface defect initiated its premature failure. Specimen 2Z40B-1 failed in the grip area.

As the last major specimen variable, some specimens were tested with an elastomeric coating over the active substrate. The results are inconclusive in that some sets of non-overcoated specimens showed better lives than their coated counterparts while others were unchanged or showed shorter lives. This can be seen by examining Figures 6, 7, and 8, or Tables IV, V, and VI.

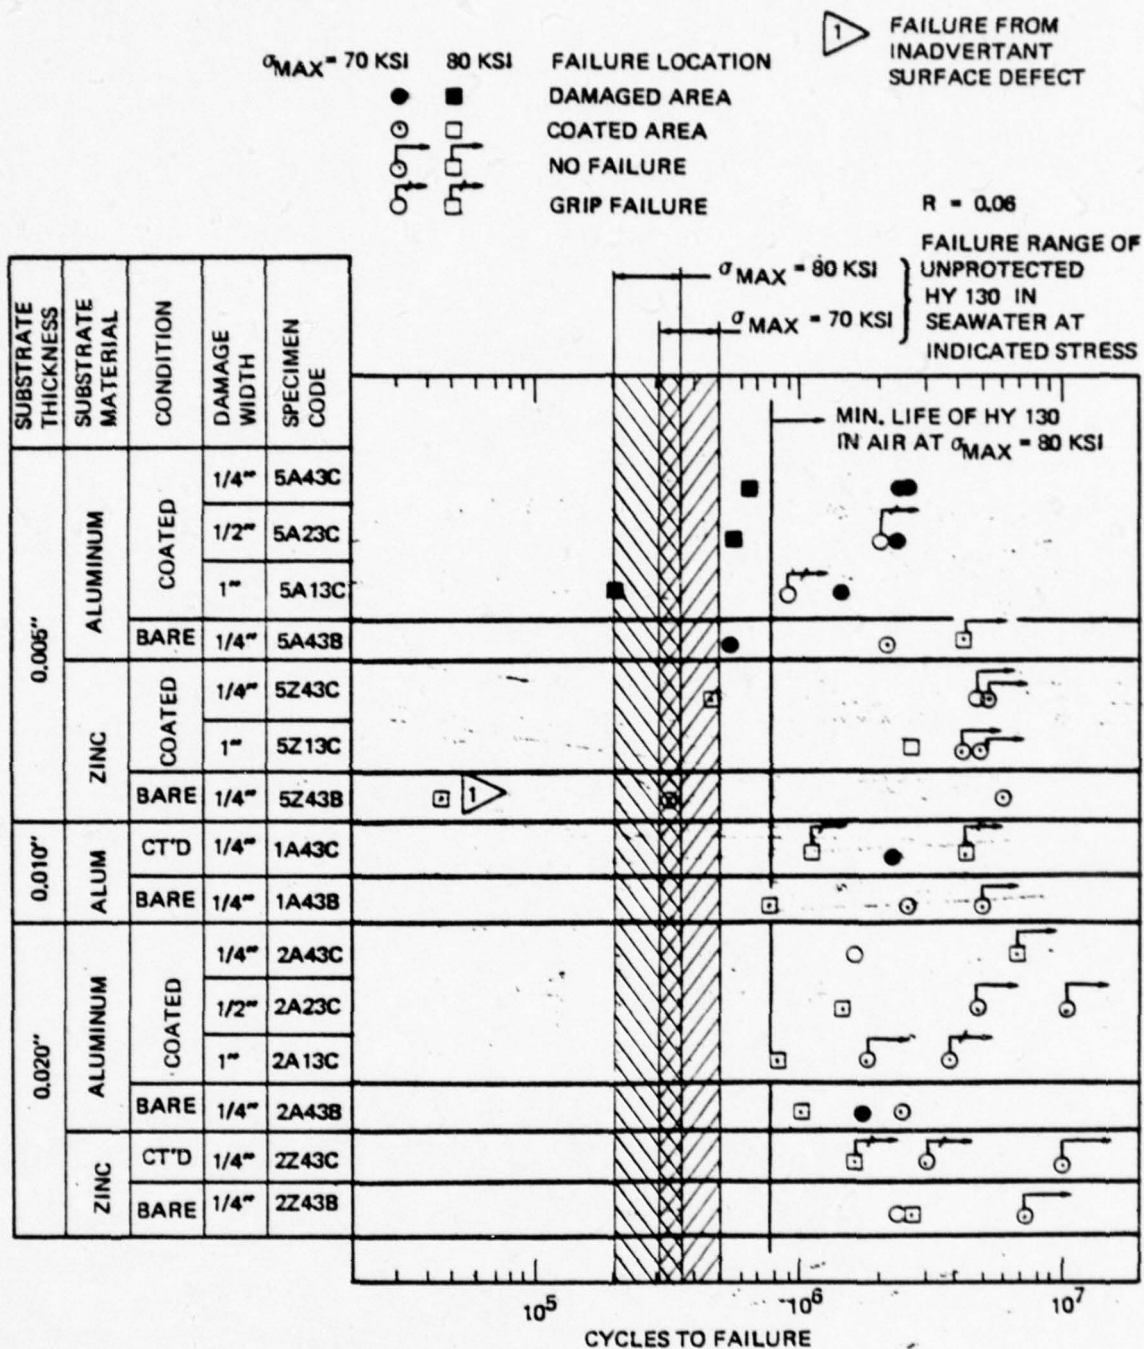
Figure 7: CYCLES TO FAILURE FOR COATED HY 130 FATIGUE SPECIMENS – 30 DAY PRIOR EXPOSURE IN FLOWING SEA WATER

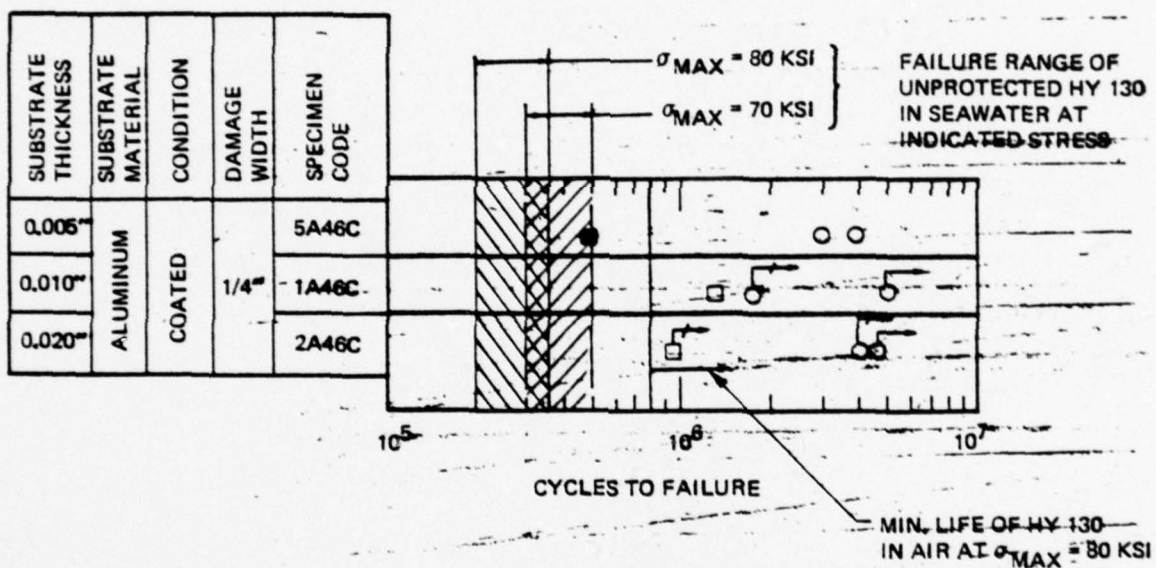
Figure 8: CYCLES TO FAILURE FOR COATED HY 130 FATIGUE SPECIMENS – 60 DAY PRIOR EXPOSURE IN FLOWING SEAWATER

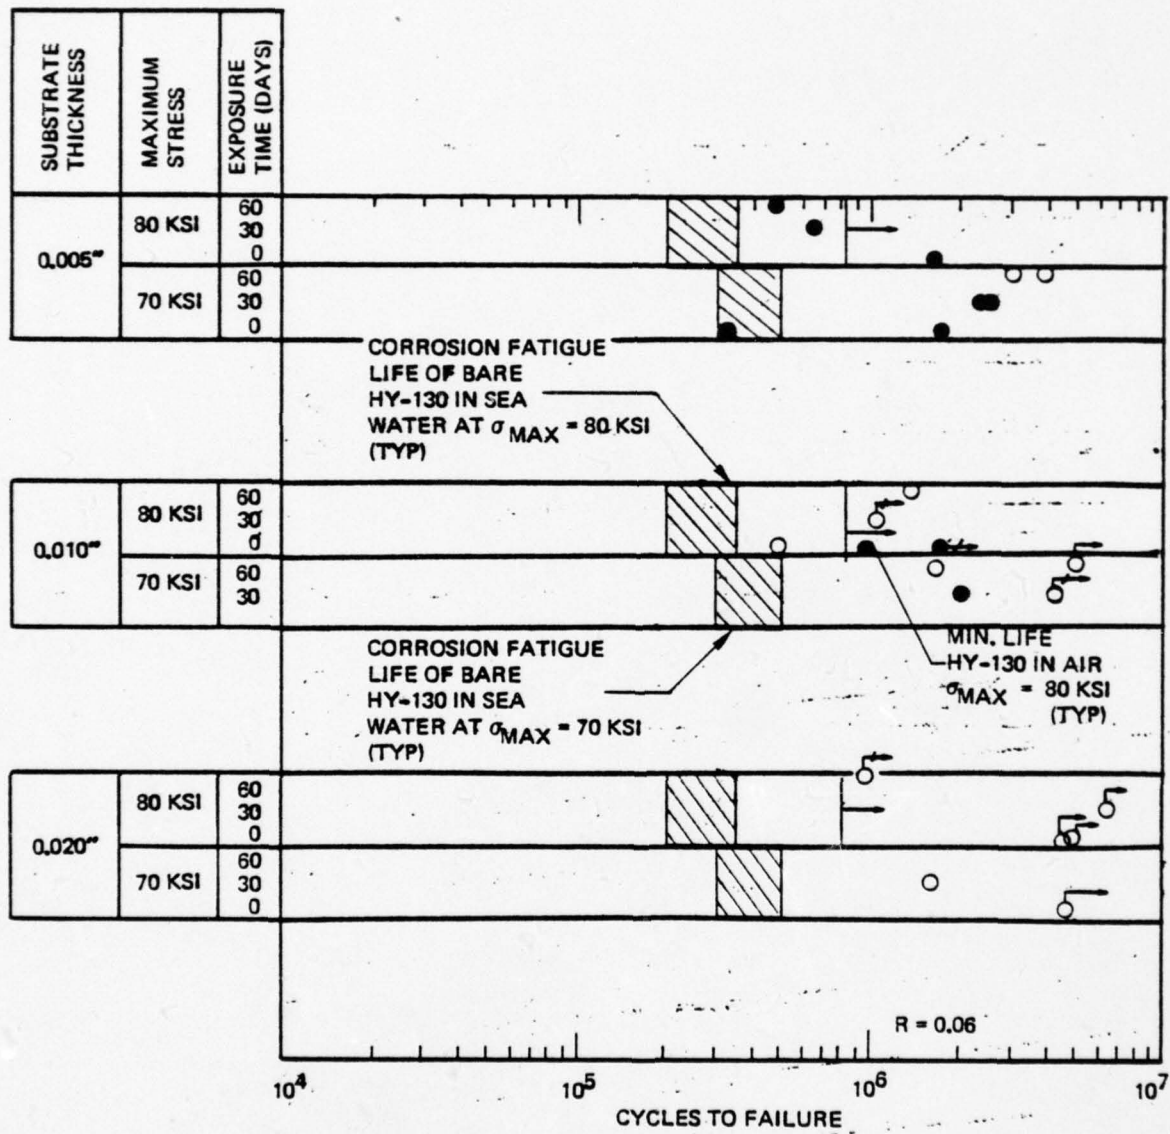
Figure 9: EFFECT OF SEAWATER EXPOSURE TIME - HY 130 STEEL, ALUMINUM SUBSTRATE, 1/4" DAMAGE WIDTH

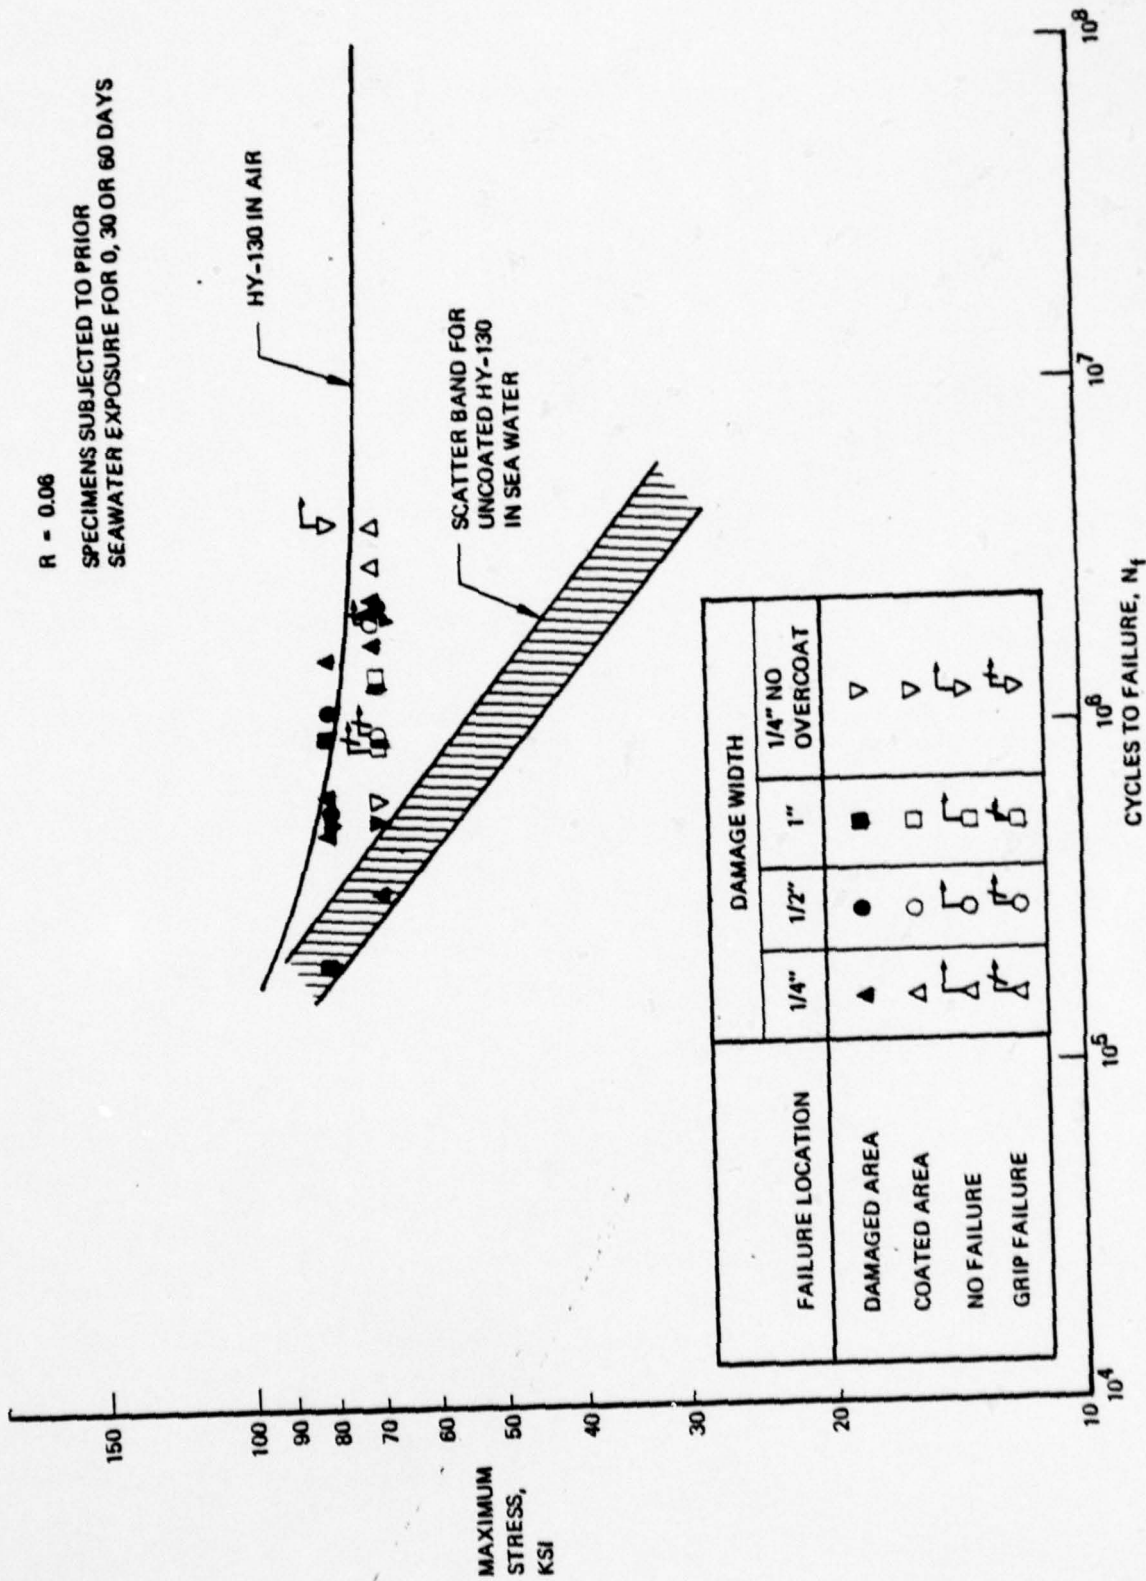
Figure 10: FATIGUE RESULTS FOR COATED HY-130 STEEL, 0.006 " ALUMINUM SUBSTRATE

lives were generally shorter for the 0.005" substrate although they were in most cases better (longer) than for bare HY130 in sea water. In addition, almost all of the failures for the 0.005" aluminum substrate were in the damaged zone, whereas fewer failures were in the damage zone for the 0.010" substrate, and two occurred in the 0.020" substrate. The data from the 0.005" and 0.020" aluminum substrate specimens are further summarized in Figures 10 and 11 respectively. These figures show the data plotted on the S-N curves for uncoated HY130 from reference 1.

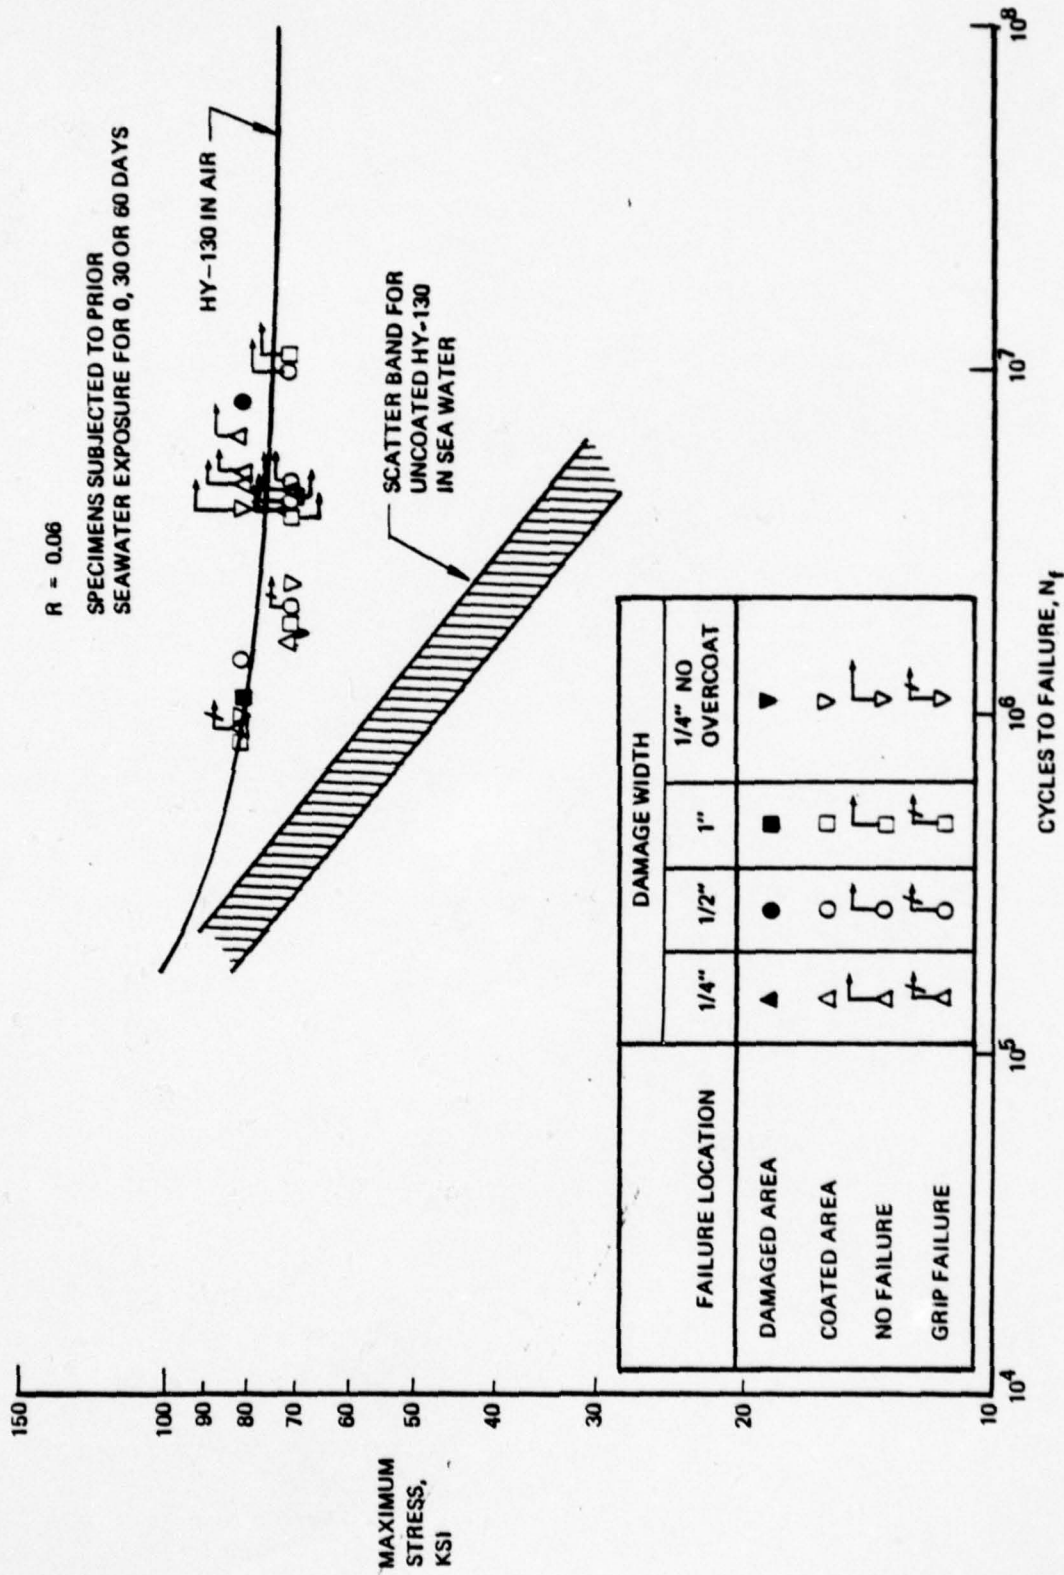
Figure 11: FATIGUE RESULTS FOR COATED HY-130 STEEL, 0.020" ALUMINUM SUBSTRATE

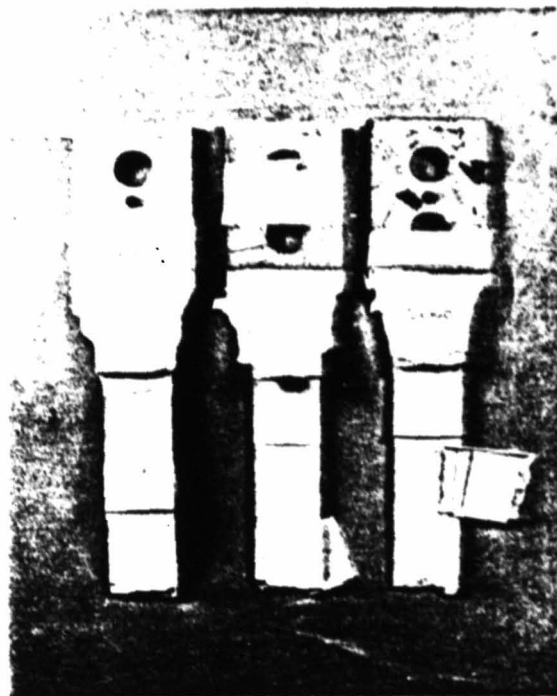
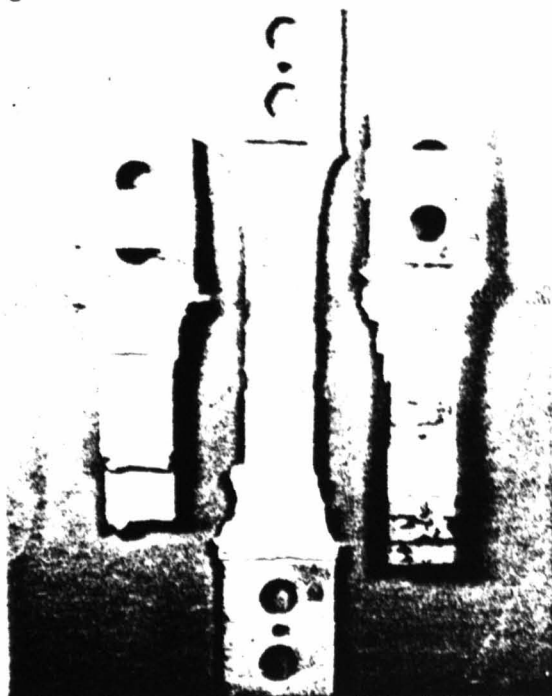
Figure 12:

TYPICAL TESTED FATIGUE SPECIMENS

As shown in Tables VII and VIII, the zinc substrate protected the specimens better than did the aluminum. However, the zinc substrate had a tendency (80-90%) to delaminate from the specimen under the fatigue loading conditions. Examples of this delamination are shown in the photograph of Figure 12. Figure 12A shows aluminum substrate specimens without delaminations and Figure 12B shows comparable zinc substrate specimen with delaminations. Aluminum did much better with respect to delamination although the 0.020" aluminum specimens showed some delamination as shown in Figure 12C. Figures 13, 14 and 15 show typical specimens after exposure to 30 day and 60 day flowing salt water prior to fatigue testing. The aluminum specimens had more brown iron oxide in the damaged area than the zinc specimens. The

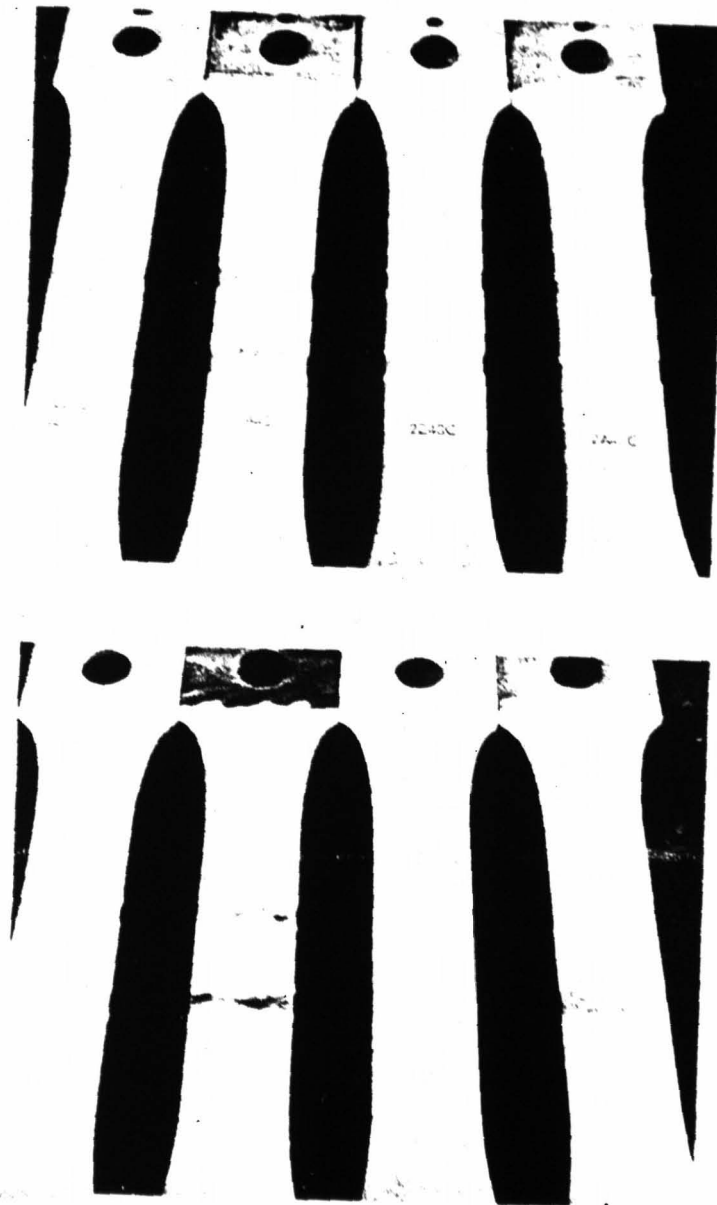
Figure 13: SPECIMENS AFTER 30 DAYS EXPOSURE TO
FLOWING SEA WATER

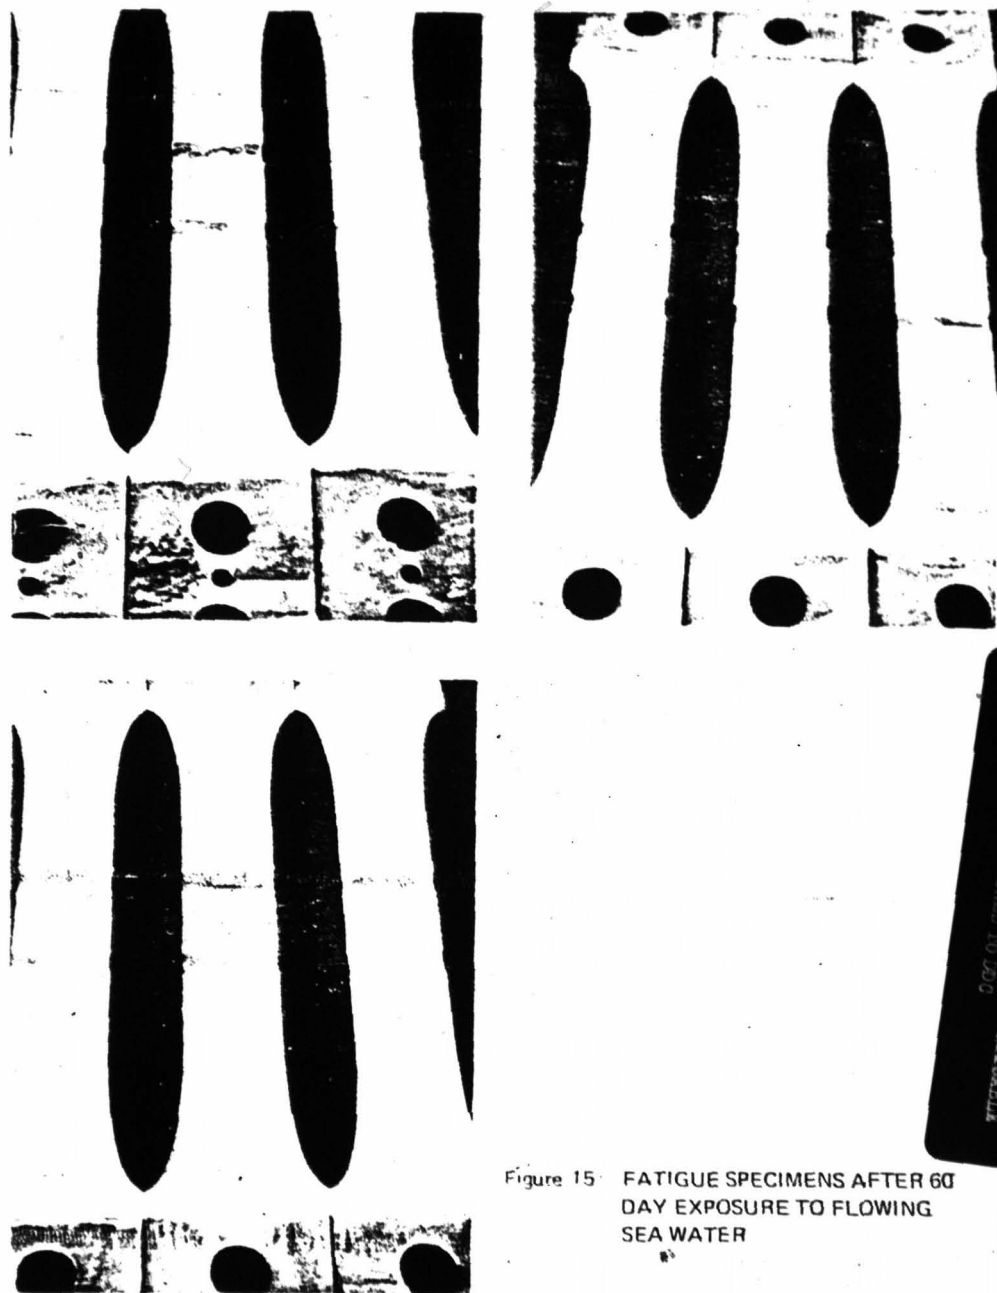
Figure 15 FATHIGUE SPECIMENS AFTER 60
DAY EXPOSURE TO FLOWING
SEA WATER

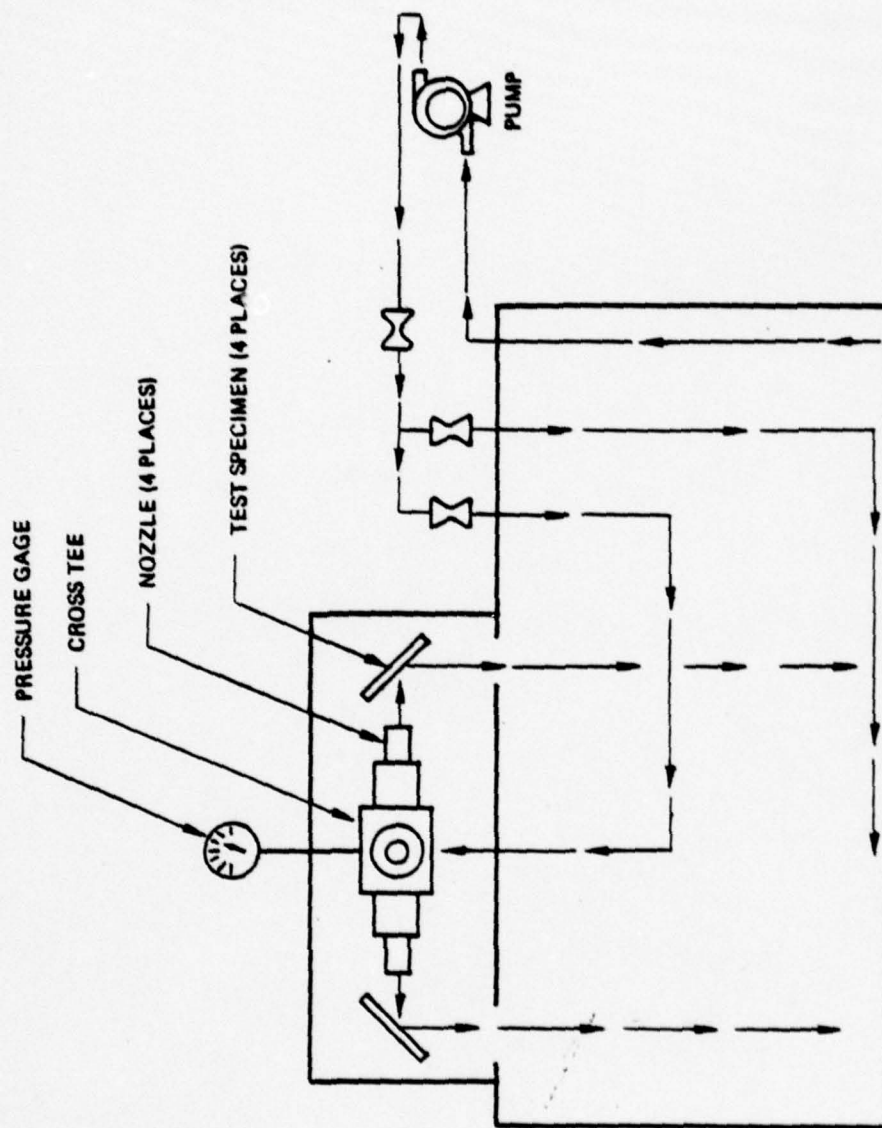
Figure 16: SCHEMATIC OF SALT WATER EROSION TEST FACILITY

Erosion testing was accomplished in the testing apparatus shown in Figures 16 and 17. The test conditions were: water velocity of 52 knots and water temperature of $100 \pm 5^\circ\text{F}$. The water velocity of the test apparatus is adjusted by controlling the flow through the valve to the cross tee (Figure 16) to maintain the pressure necessary to obtain 52 knots at the nozzle as shown in the calibration curve in Figure 18. The water temperature is controlled by a cold water cooling coil in the sump.

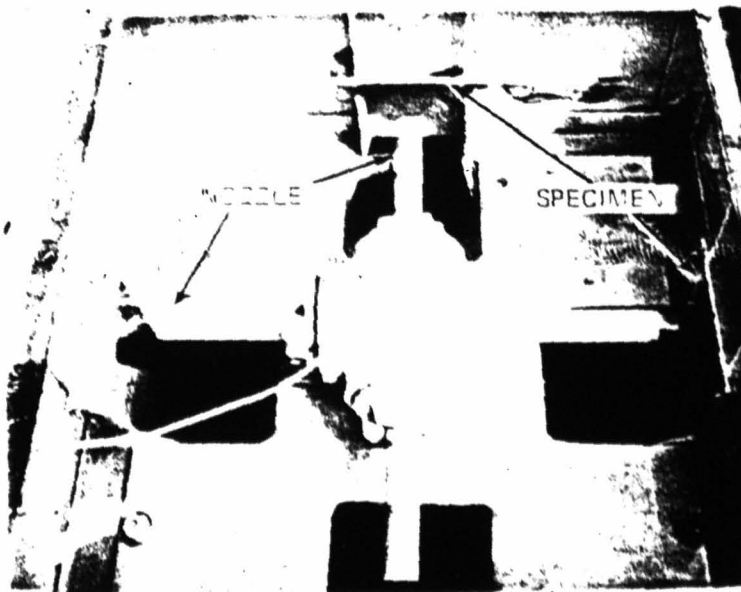
OVERALL VIEW

VIEW OF NOZZLES AND SPECIMENS

Figure 17: SALT WATER EROSION TEST FACILITY

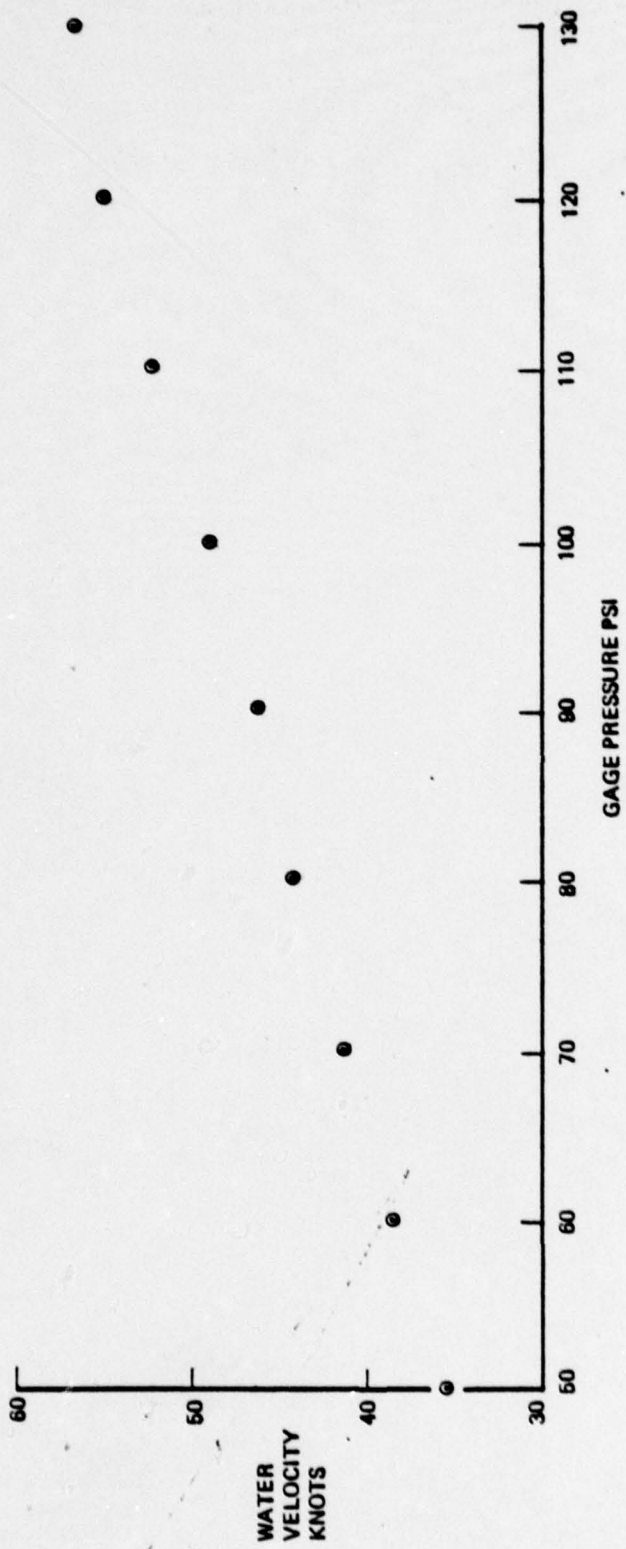
Figure 18: GAGE PRESSURE vs WATER VELOCITY AT NOZZLE --
SALT WATER EROSION TEST FACILITY

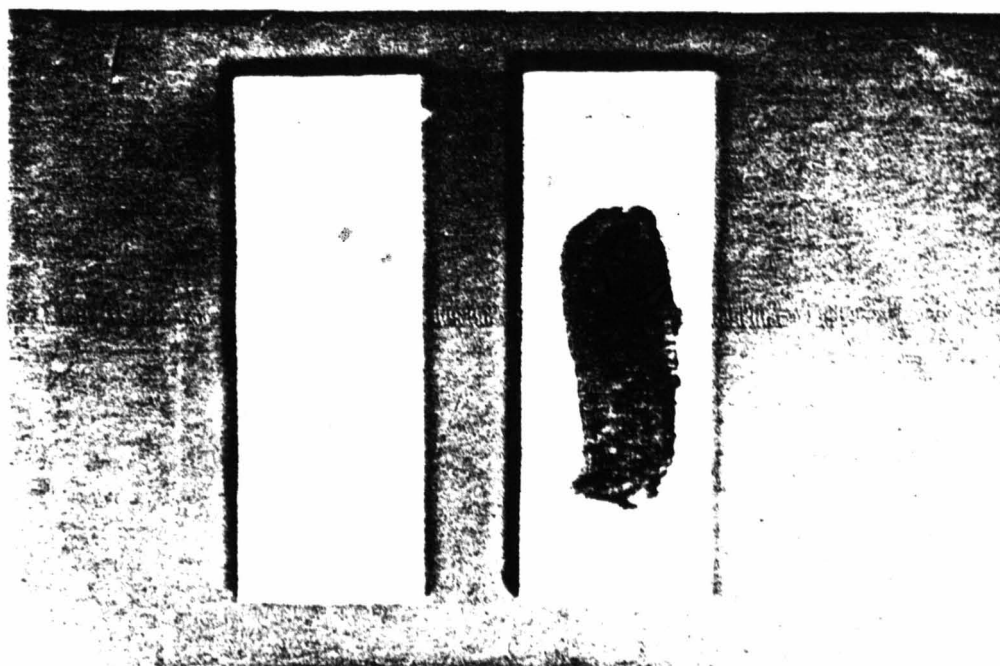
Figure 19 TYPICAL REPAIR SPECIMENS AFTER EROSION TESTING

The erosion testing results are shown in Table IX and typical specimens after testing are shown in Figure 19 and 20. The erosion testing zones are at the point of direct impingement from the nozzle and the splash zones are on each side of this area.
